High-performance Waterproofing Protects Bridge Deck

ELIMINATOR® and METASET® systems used on £1.5m Putney Bridge repair and refurbishment project

Project	Putney Bridge, London, UK
Client	Wandsworth Borough Council
Contractor	FM Conway
Authorised Contractor (Waterproofing Applicator)	Metrail Construction Ltd
GCP Solutions	ELIMINATOR® Bridge Deck Waterproofing and METASET® systems

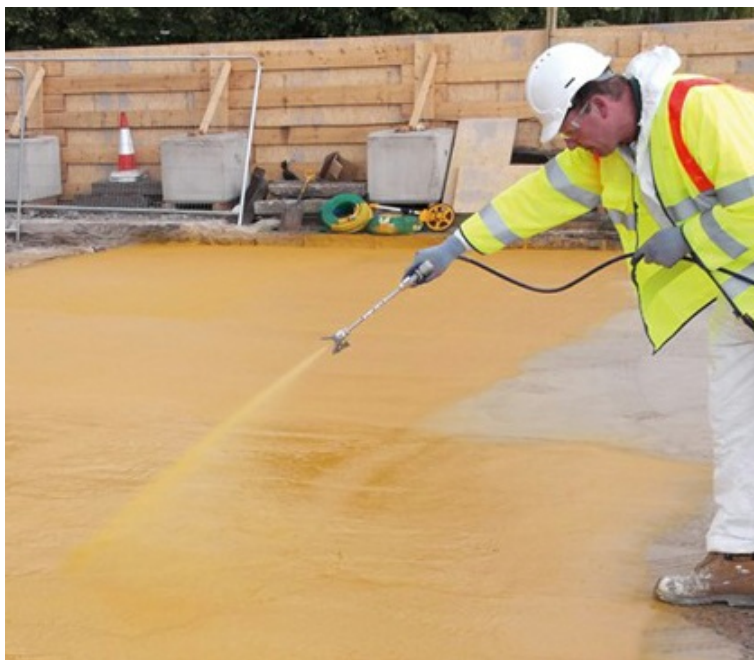
The Grade II listed arch bridge which crosses the Thames had a Ground Penetrating Radar (GPR) report undertaken in 2010, which identified the deck as having areas with significant moisture and even saturation within its roadway and supporting structure. The bridge was in need of protection from water penetration to prevent structural damage.

On site, the existing surfacing and waterproofing, along with the curb detail, were removed by main contractor, FM Conway. Wandsworth Council's in-house engineering consultancy assessed the bridge structure and found that the existing polyurethane waterproofing system had completely de-bonded and delaminated from the concrete substrate. In addition, loose, friable material needed to be replaced with a robust, concrete detail. Metrail Construction Ltd repaired the bridge, applied waterproofing, added new paving stone and upgraded the drainage system.

Wandsworth Council specified the **ELIMINATOR**[®] system from Stirling Lloyd (now GCP Applied Technologies) as an immediate, cost-effective solution for waterproofing the surface and curb areas since its fast cure time would reduce bridge closure times. **METASET**[®] Resifilla was chosen for the deck repair since it achieves very high early compressive strengths, excellent thermal and mechanical shock resistance and also cures rapidly across a wide range of temperatures.
