DCI®

DCI performance in cracked concrete

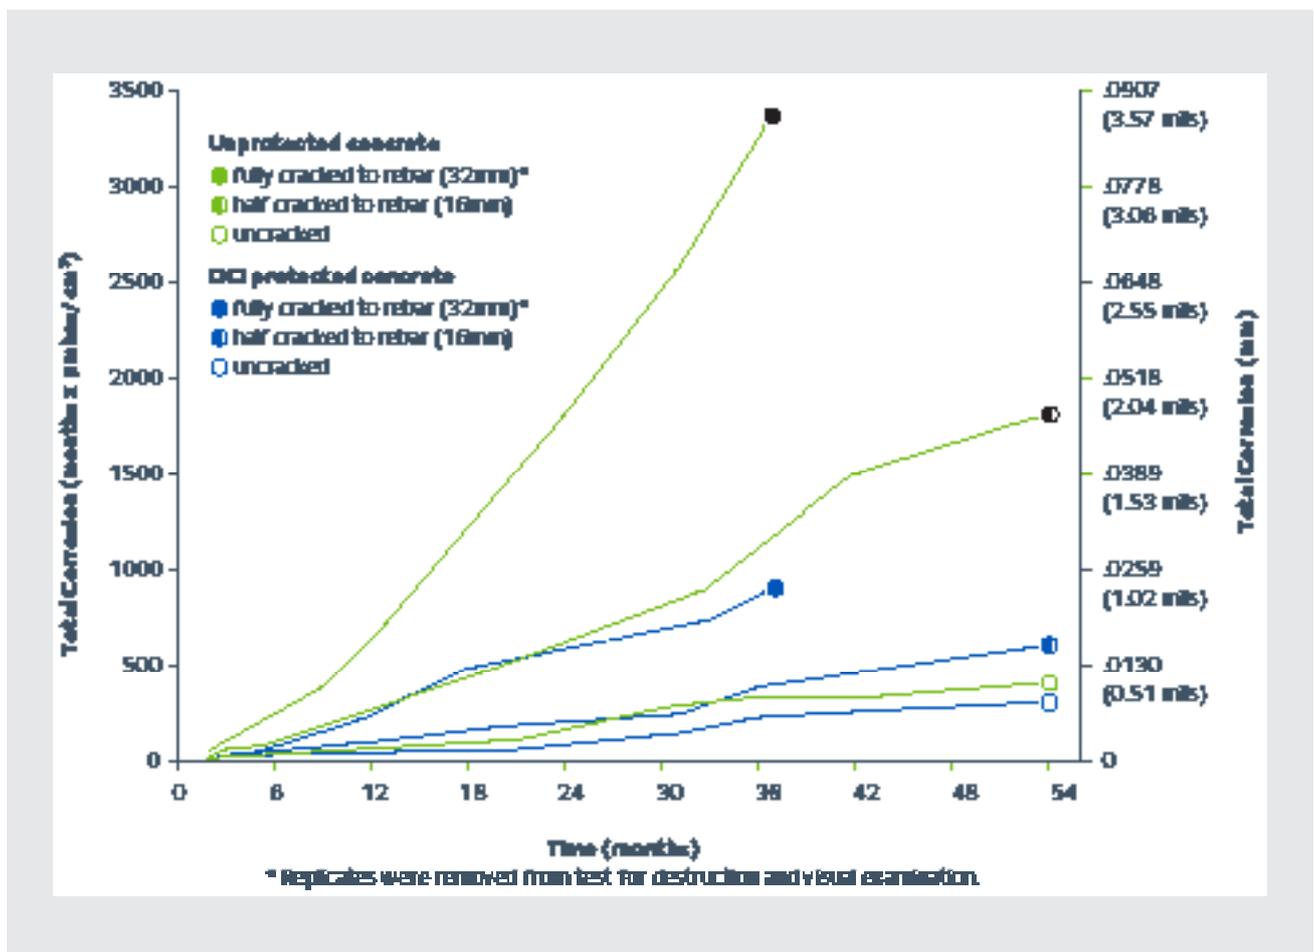
Figure 1- Total Corrosion vs. Time

Three sets of specimens were produced in 100mm x 125mm x 405mm molds with 32mm of cover over a number three rebar. The first set was third point loaded to produce a crack down to the rebar, the second set loaded to produce a crack halfway down to the rebar, and the third set remained uncracked. Half the test specimens contained DCI corrosion inhibitor at 20L / m³ of concrete while the remaining specimens were unprotected references. All concrete had a water-cement ratio of 0.45 and an average cement factor of 410kg / m³. The specimens were alternately ponded with a 3% sodium chloride solution and then dried on a weekly basis. This laboratory study is considered to be more severe than actual field conditions. Corrosion potentials, corrosion rates, total corrosion and specimen appearances were monitored every month. Concrete cracks measured .23mm at the surface.

- As shown in Figure 1, DCI-protected concrete specimens have much lower total corrosion than their corresponding unprotected references.
- The fully-cracked, DCI-protected specimens have total corrosion less than that of the unprotected half-cracked concrete specimens.
- The DCI-protected, half-cracked to the rebar specimens have total corrosion equivalent to that of the unprotected, uncracked concrete specimens.
- The unprotected, full-cracked reference specimens have developed severe corrosion. Staining and rust-caused cracking has begun. This is in good agreement with other studies that show that over .0254mm average corrosion will induce concrete cracking. The DCI-protected, fully-cracked specimens do not show these signs of distress.
